Manhole Inspection Summary

Manhole # S45C__009MH

Insp Date: **8/18/08 11:39 AM**

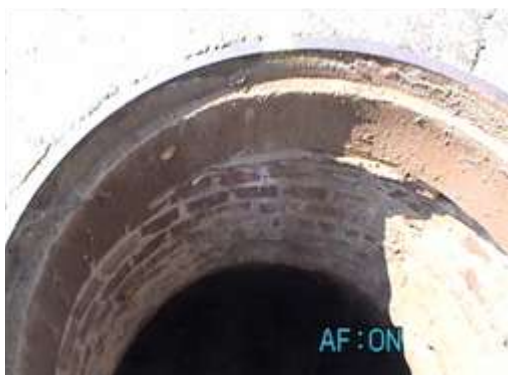
Defect 2

Infiltration: ☐ None ☐ Joint ☐ Cracks ☒ **Mortar** ☐ Roots ☐ Wall

Infiltration

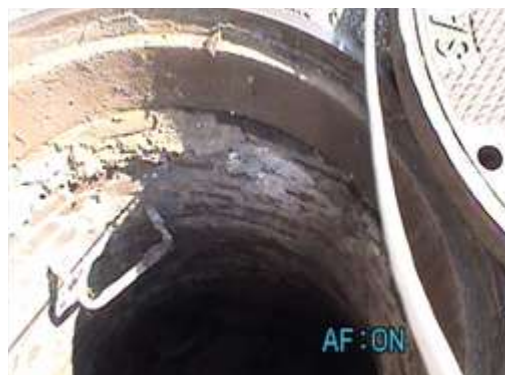
Defect 1

☒ **Leaks**

Frame leaks

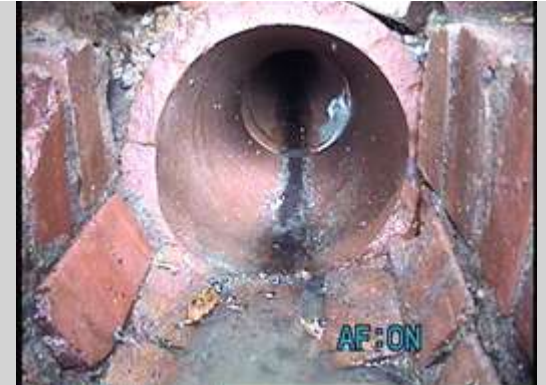
12 O'Clock Outflow

8 in. Circular Gravity Sewer
Pipe Out @ 12 O'Clock

Pipe Height: **8.4** (in.) Rod and Bar (Angled)
Pipe Material: **Clay** ☐ Pipe Lined
Invert Depth: **8.95** (ft.) Flow Characteristics: **Slow**
Deposits: ☒ None ☐ Mud ☐ Sludge ☐ Debris ☐ Grease
Silt Depth: (in.) Deposits Extent:
Infiltration: **None** Pipe Seal Cond: **Sound**

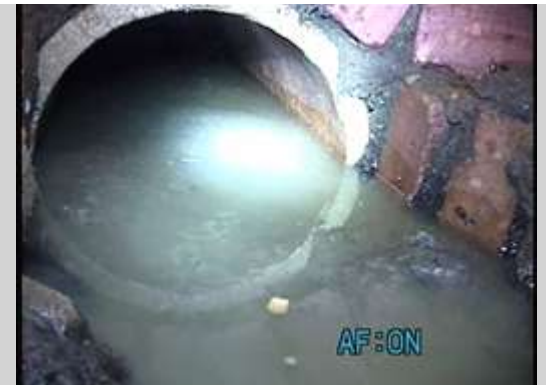
3 O'Clock Inflow

8 in. Circular Gravity Sewer
Pipe In @ 3 O'Clock

Pipe Height: **8.4** (in.) Rod and Bar (Angled)
Pipe Material: **Clay** ☐ Pipe Lined
Invert Depth: **9.10** (ft.) Flow Characteristics: **Slow**
Deposits: ☒ None ☐ Mud ☐ Sludge ☐ Debris ☐ Grease
Silt Depth: (in.) Deposits Extent:
Infiltration: **None** Pipe Seal Cond: **Sound**

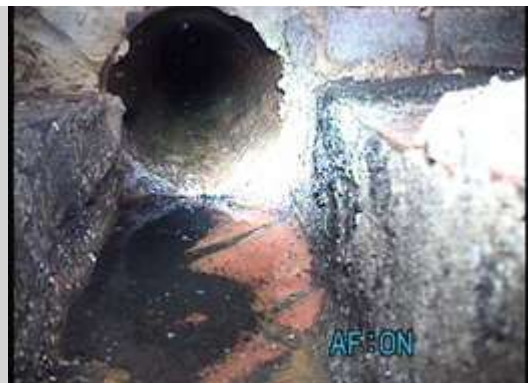
8 O'Clock Inflow

Pipe In @ 8 O'Clock

Infiltration: **None** Pipe Seal Cond: **Sound**
